### HAZARDOUS MATERIALS SURVEY

LADREY SENIOR HIGHRISE APARTMENTS

300 WYTHE STREET ALEXANDRIA, VIRGINIA 22314

FEBRUARY 4, 2021

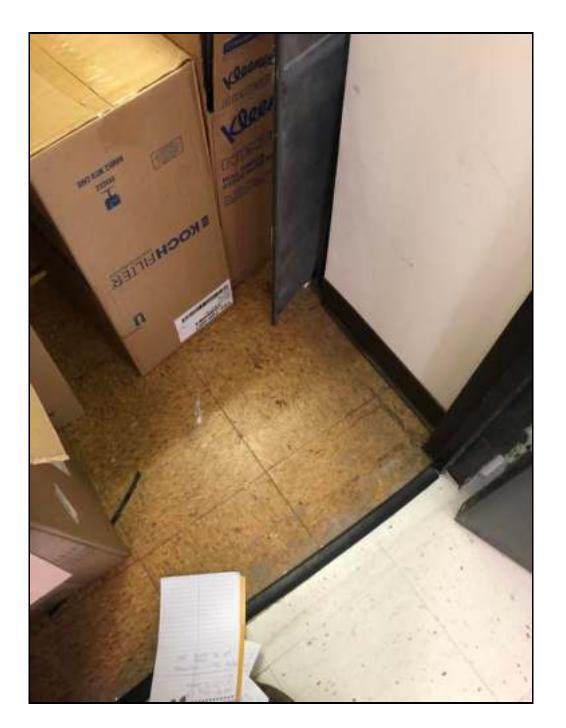
ECS observed asbestos-containing brown mastic associated with 12" x 12" brown with brown streaks floor tile in the first floor western hallway, first floor game room, and storage and electrical closets throughout the building. Asbestos-containing mixed mastics and leveling compound associated with 12" x 12" white with gray flecks floor tile was observed in the first floor eastern stairwell and first floor northern hallway. ECS recommends that black or brown mastics observed throughout the building should be considered asbestos-containing or additional delineation should be performed.

1 - Asbestos-containing brown mastic associated with 12"x12" brown with brown streaks floor tile

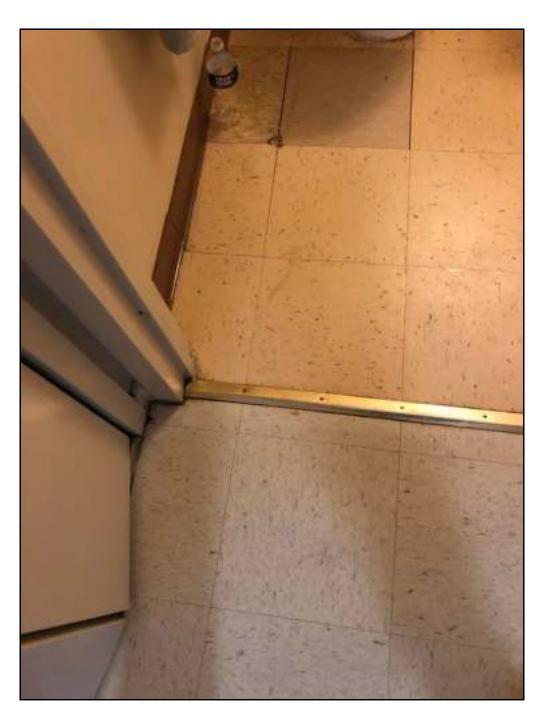
ECS also observed asbestos-containing tan linoleum sheeting under floor tile in bathrooms and kitchens in multiple locations. Asbestos-containing brown stone print linoleum sheeting was observed in the kitchens of several units and is assumed to be present in other locations throughout the building.

2 - Asbestos-containing linoleum sheeting under floor tile was observed in bathrooms and kitchens

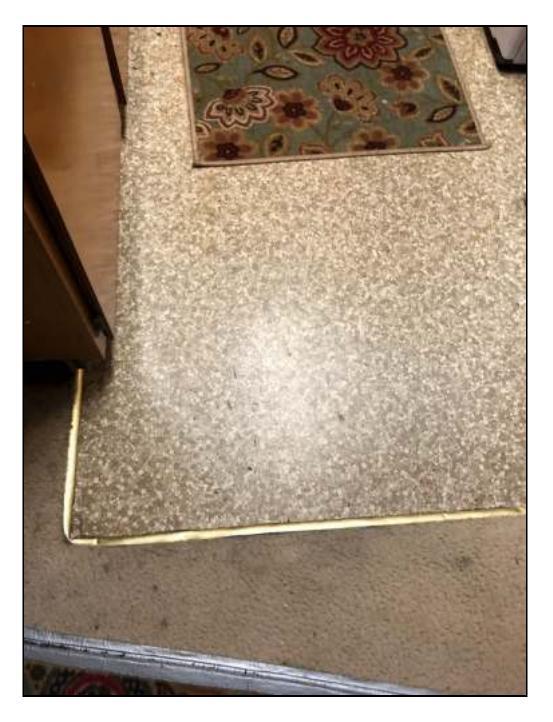
3 - Asbestos-containing brown stone print linoleum sheeting

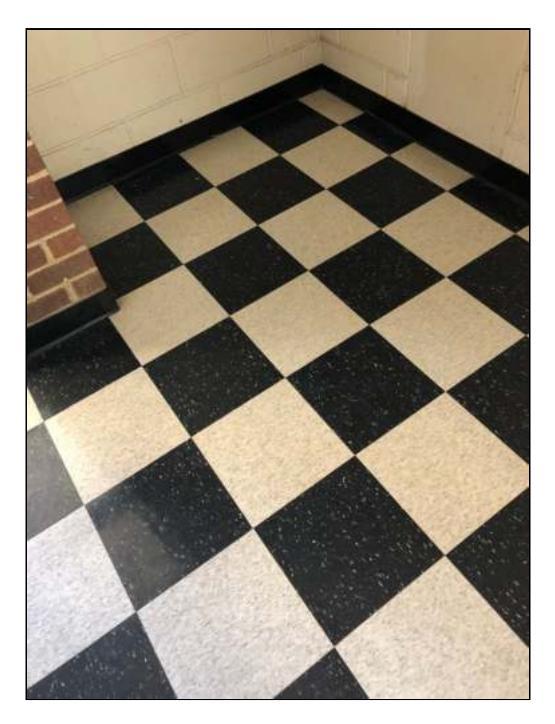
4 - Asbestos-containing mixed mastics and leveling compound associated with 12"x12" white with gray flecks floor tile

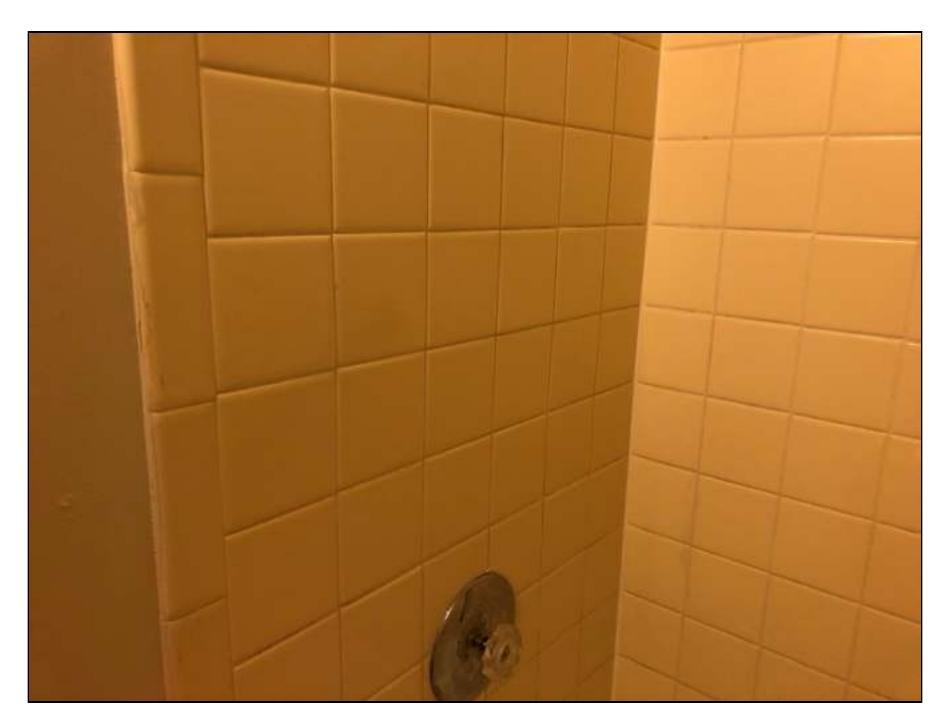
5 - Lead-based beige ceramic tile

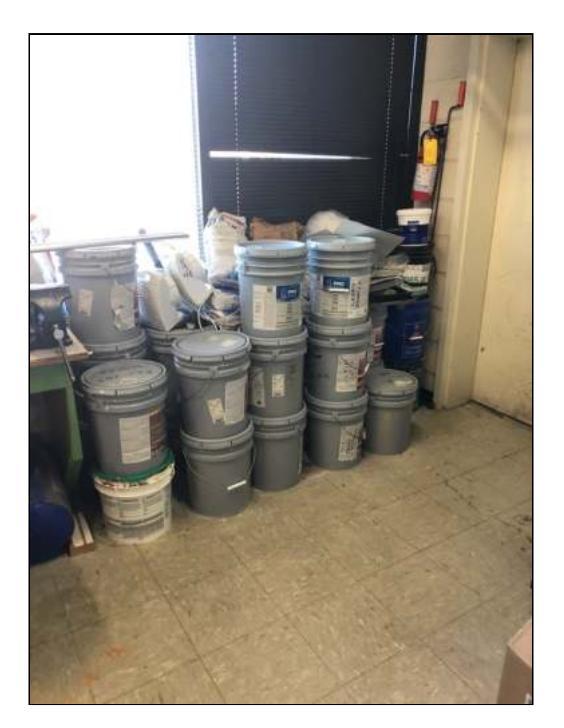
6 - Household paints and chemicals

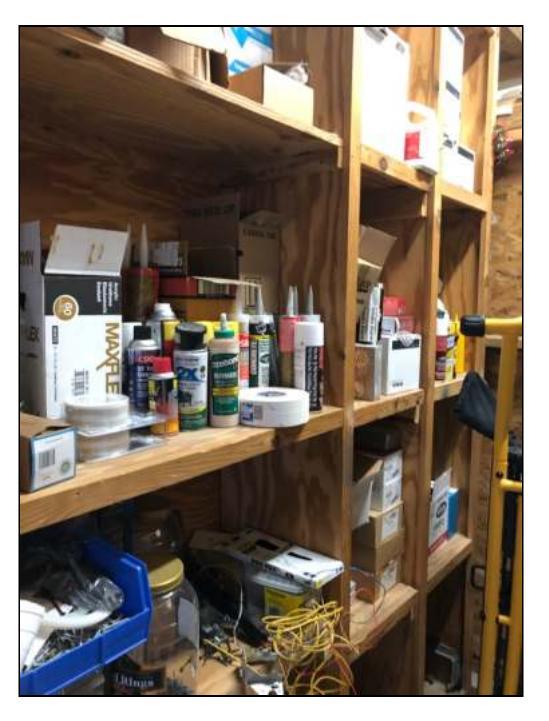
7 - Household chemicals

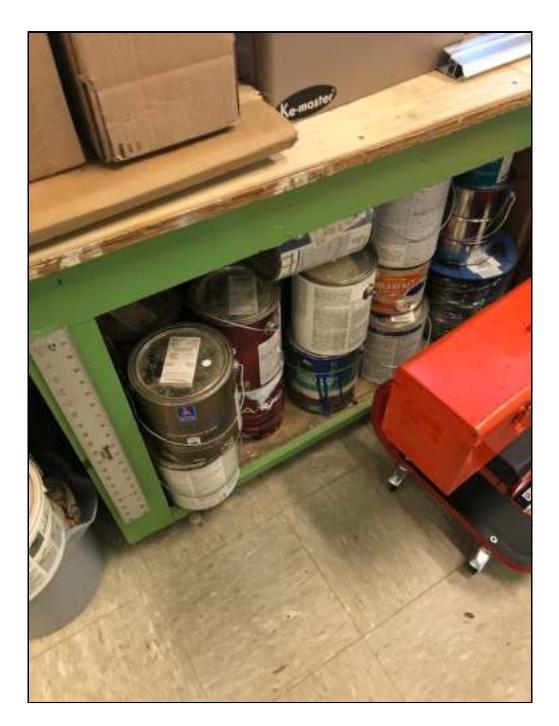
8 - Household paints and chemicals

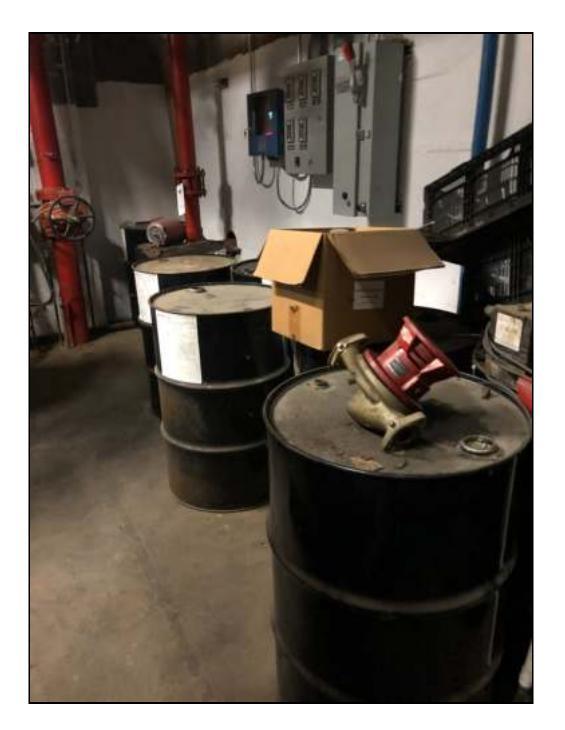
Refrigerators, freezers, exit signs, household cleaning supplies, paint, unknown drums in the boiler room, and fire extinguishers were observed on site.

9 - Drums in the boiler room

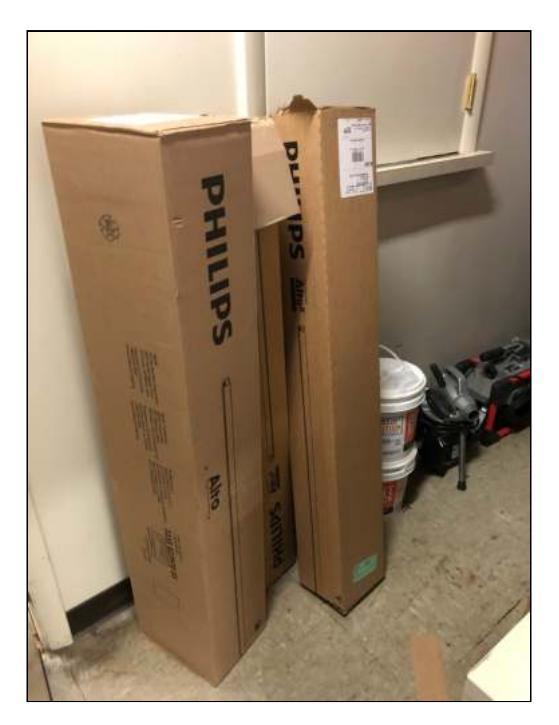
As previously discussed, fluorescent lamps were observed. The fluorescent lamps may contain small quantities of mercury.

10 - Mercury-containing light tubes

ECS recommends that fluorescent lamp tubes/bulbs suspected to contain mercury be properly recycled or disposed of in accordance with EPA and Commonwealth of Virginia regulations. Recycling is the most environmental friendly means of disposal for these materials. Fluorescent lamps may be disposed as universal waste if they remain unbroken during removal. If bulbs are crushed or broken prior to disposal, they are classified as hazardous waste by the EPA.
